**Closeout Report  
for IHSS Group 700-7**

**UBC 779, IHSS 700-138, IHSS 700-149.2,  
IHSS 700-150.6, IHSS 700-150.8,  
PAC 700-1105, and Portions of  
IHSS 000-101 and IHSS 000-121**

**September 2004**

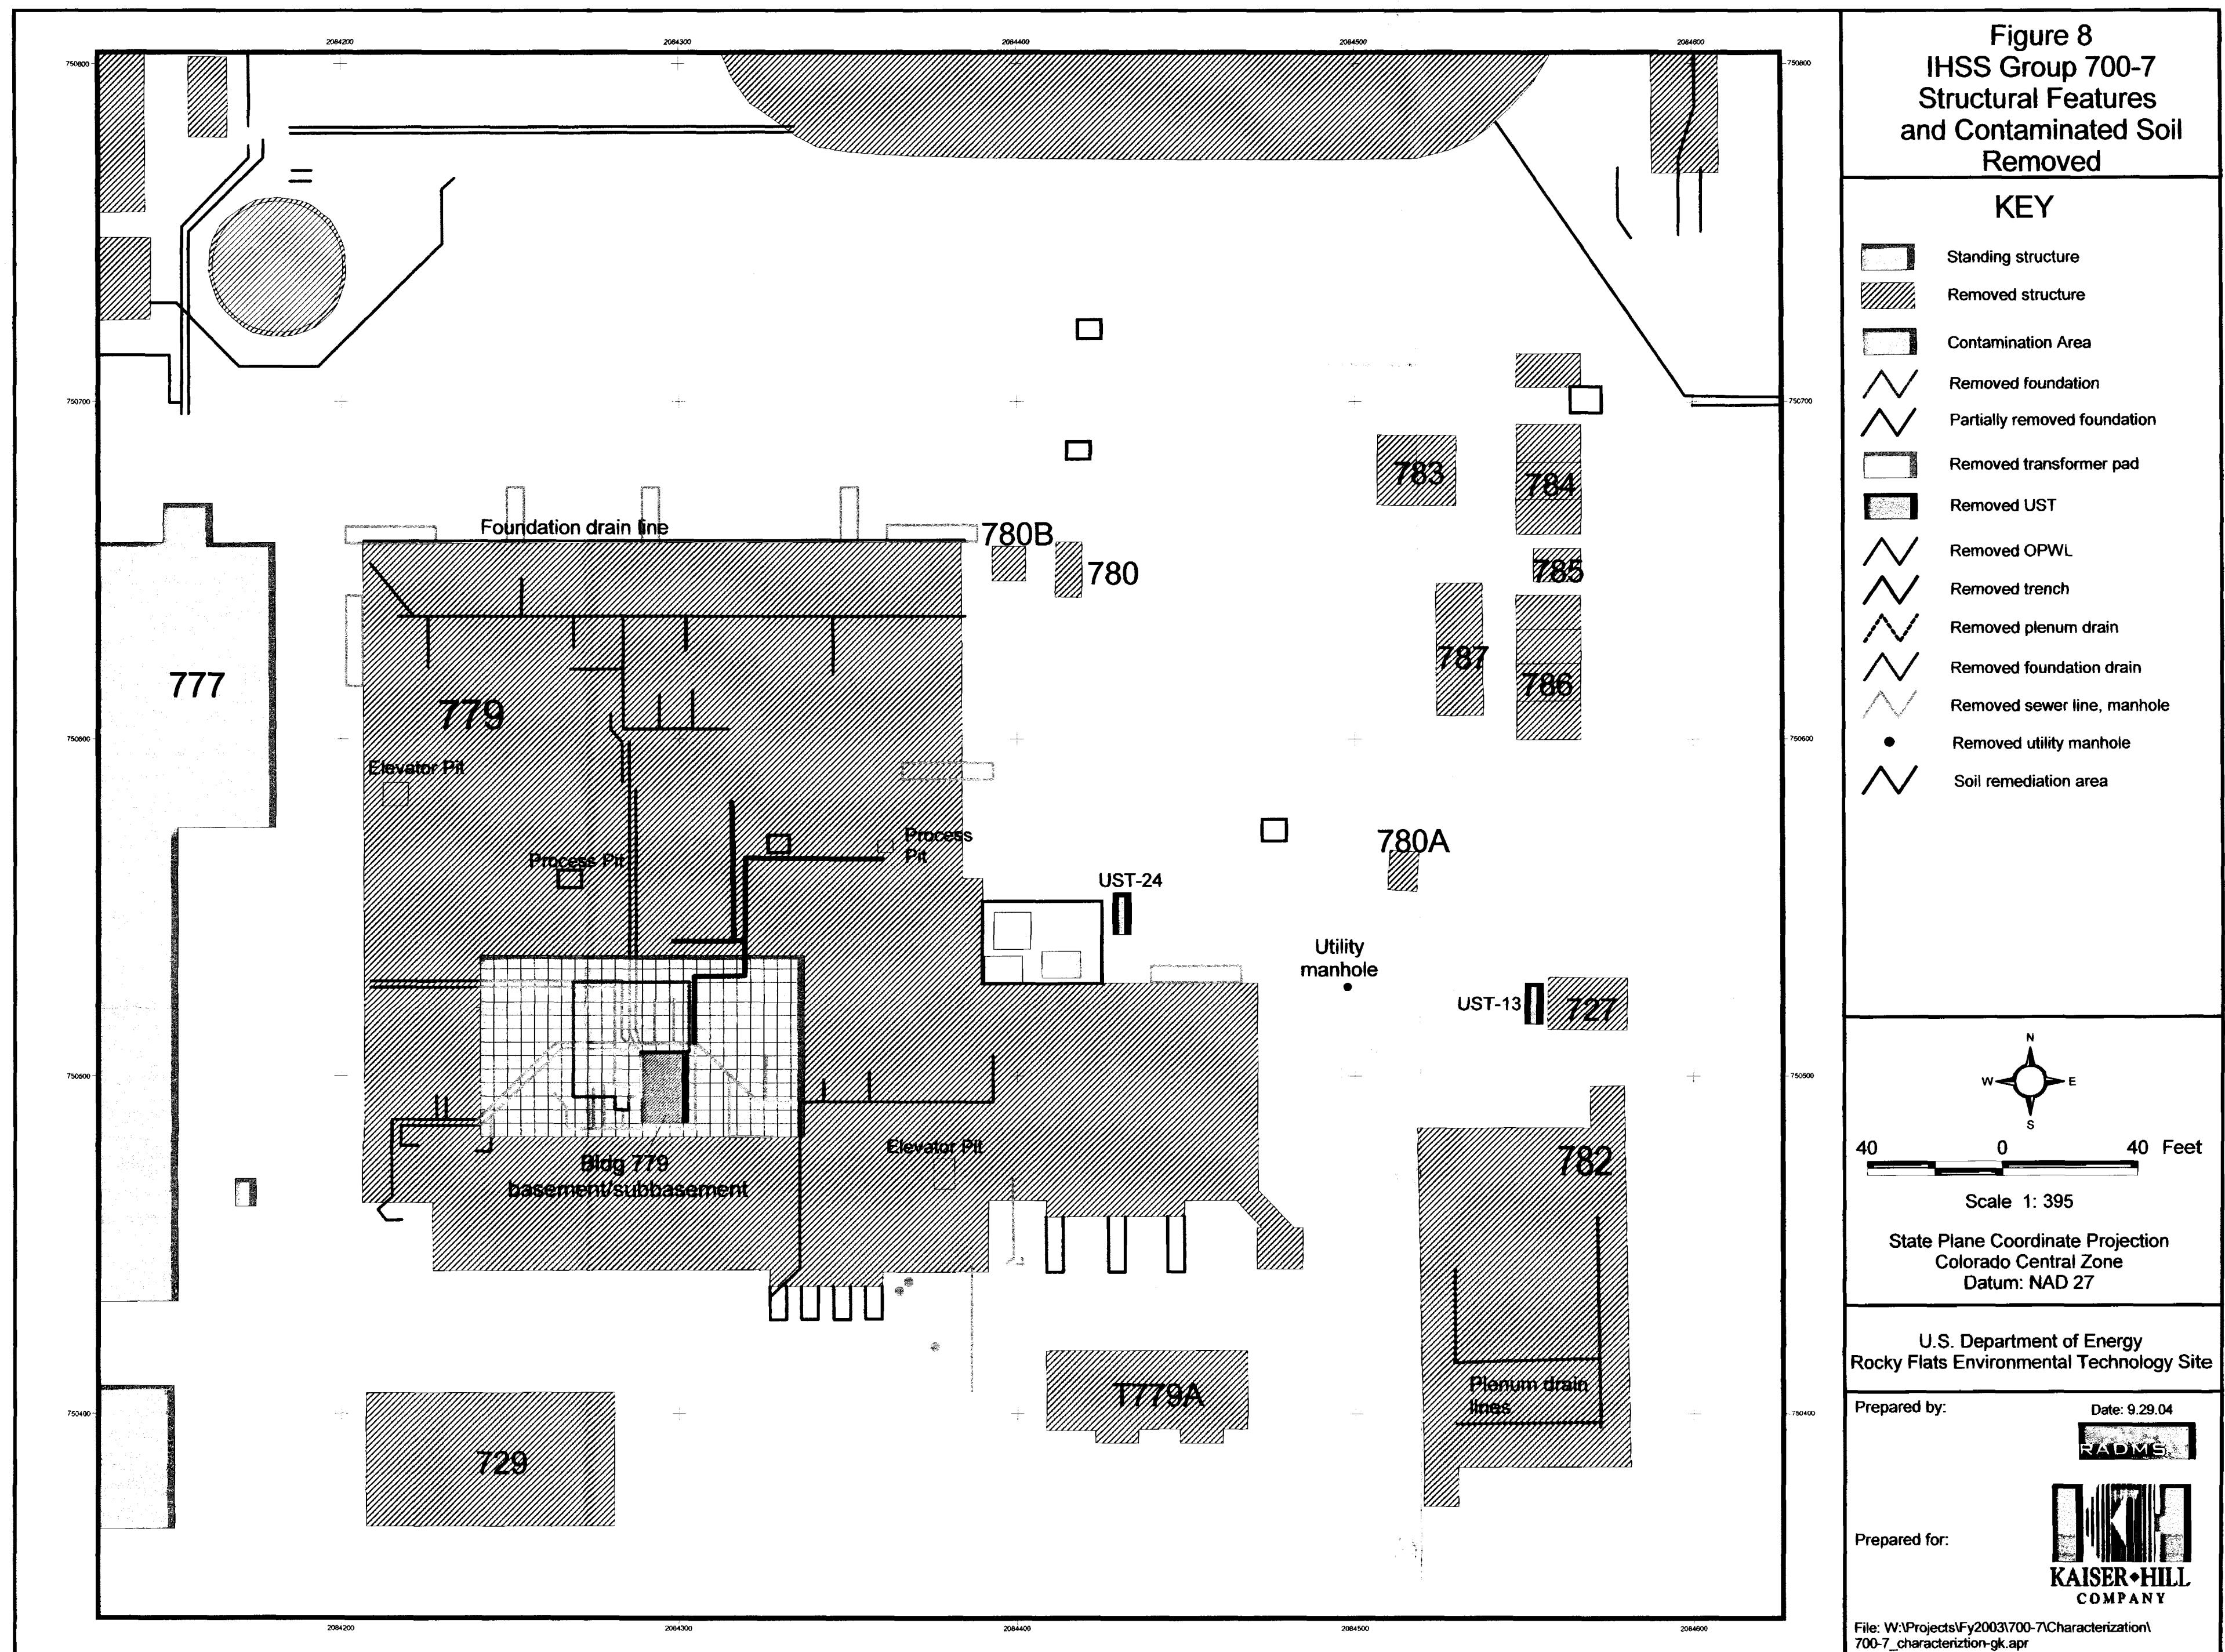
**Figure 8  
IHSS Group 700-7  
Structural Features  
and Contaminated Soil  
Removed**

The Building 779 slab (100 percent) was removed, as well as footer walls and the spread footers located under the walls. Some of the 14 structural upgrade foundations (highly reinforced and thickened portions of the slab [4-6 ft thick]) were either completely or partially removed (to 3 feet below final grade). Other Building 779 components removed include the east dock, waste trenches, a recirculation system sump near the trenches, several floor sinks, the plenum deluge drain pit, the pump pit, the two elevator pits, a sump near the west elevator pit, and the top 4 feet of the basement walls. Building 779 utilities encountered within 4 feet from the ground surface, including gas, electrical, and water lines, were also removed, as well as retrievable basement and sub-basement ladders, grates, piping, pumps, and other non-concrete equipment. The three fire-risers for the building fire suppression system were cut off 4 feet below grade and grouted. Excavators were used to break up and remove most of the items. Saws were used to cut up the radioactively contaminated section of the Building 779 slab (into 4 by 4-feet squares), and cranes were used to remove those squares. The Building 779 Contamination Area (CA) is shown on Figure 8, as well as all major items removed within the IHSS Group. All major items remaining are shown on Figure 9.
